A MULTIDISCIPLINARY ENGINEERING  
GEOLOGICAL INVESTIGATION OF CLIFF  
COLLAPSE AT REDCLIFFS IN THE  
22 FEBRUARY AND 13 JUNE 2011  
EARTHQUAKES

A thesis

**Master of Science in Engineering Geology**

2013

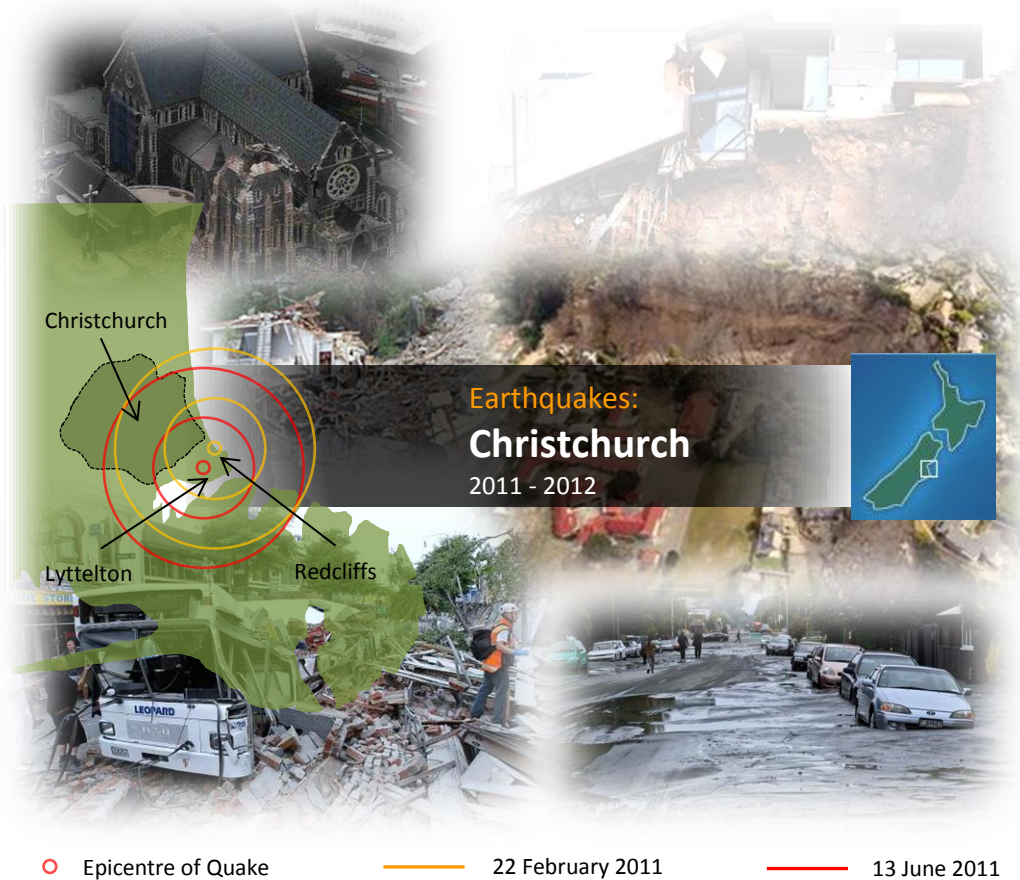
**Figure 1 – Collage of photographs illustrating the severity of the Christchurch earthquakes that struck on 22 February 2011 and 13 June 2011**

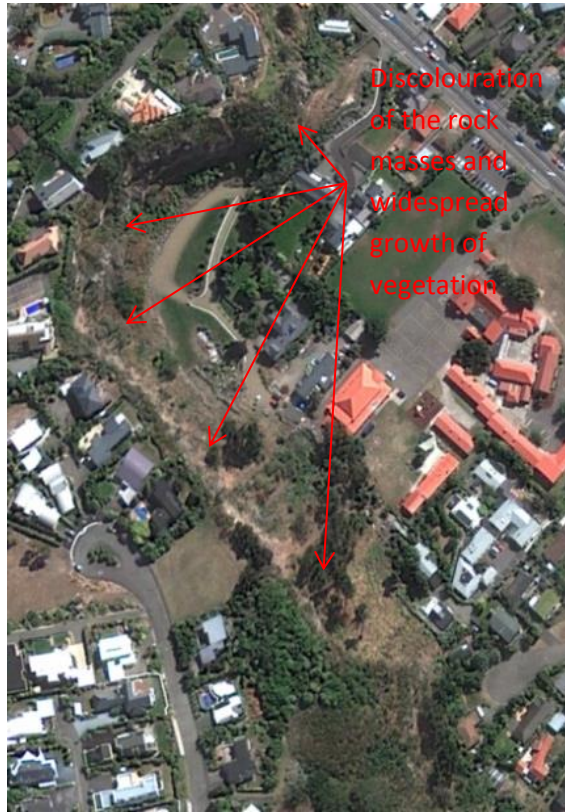
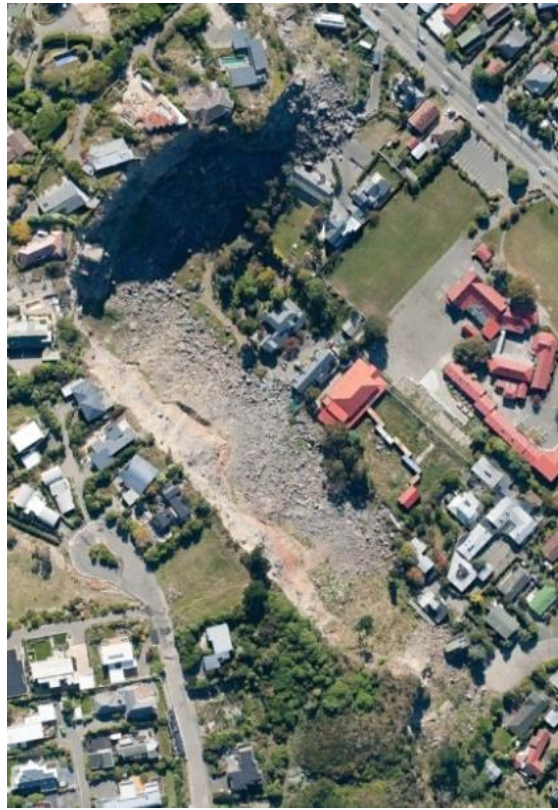
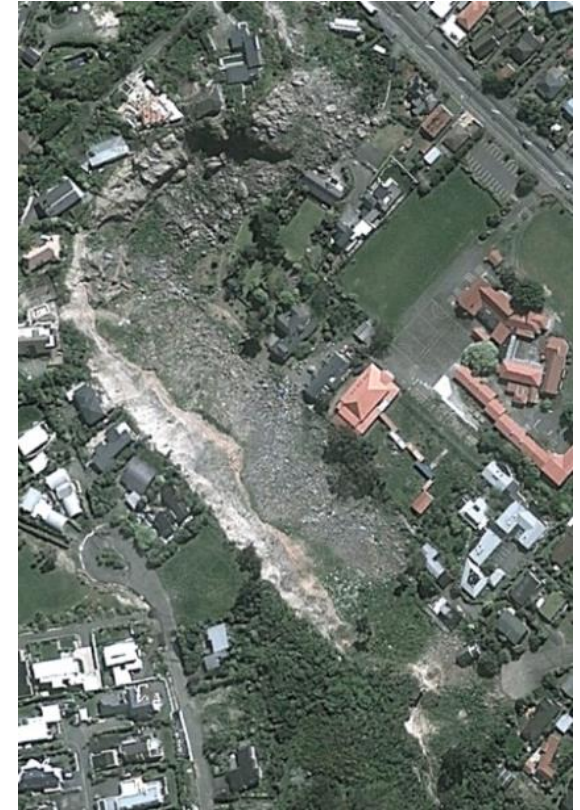
Figure 21 – Satellite images taken before and after the February 2011 collapse and post-June 2011 collapse of Redcliffs' cliff (Google, 2010). It is clear based on the satellite images that before the collapse in the 22 February 2011 earthquake that the cliff face had remain stable for a significant amount of time considering the flourish of vegetation seen across the cliff face and the weathered discolouration of the rock masses.

it was concluded that there is variability across the cliff face at three different sample scales (before each collapsing incident): the overall slope; between the NE and SE Face; and within each rock mass (within the respective slope aspect).

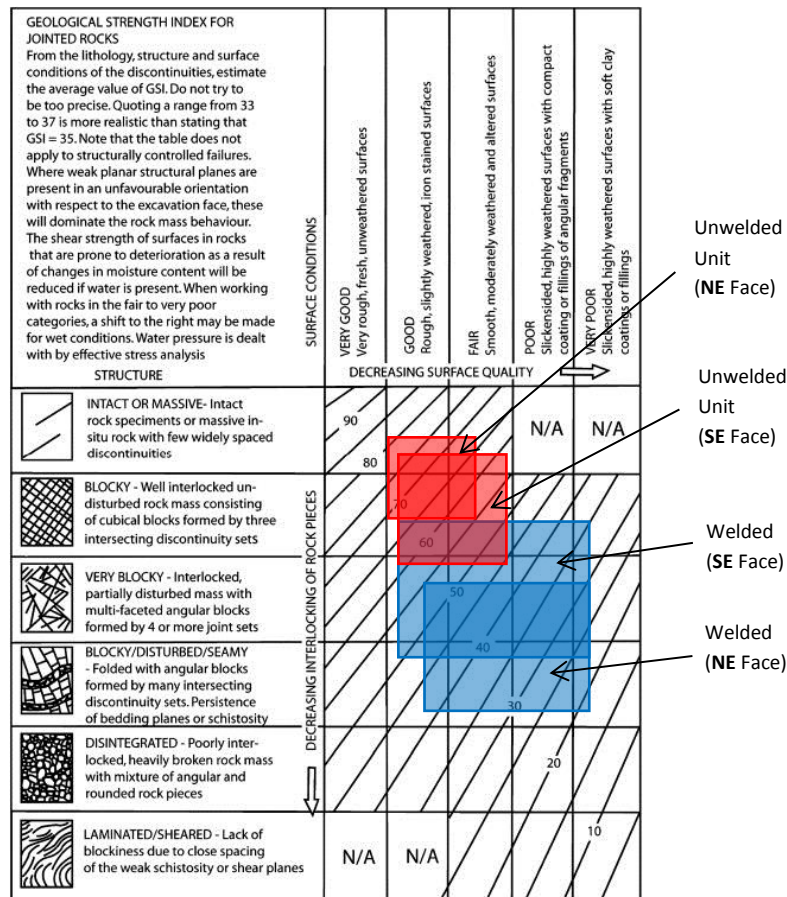
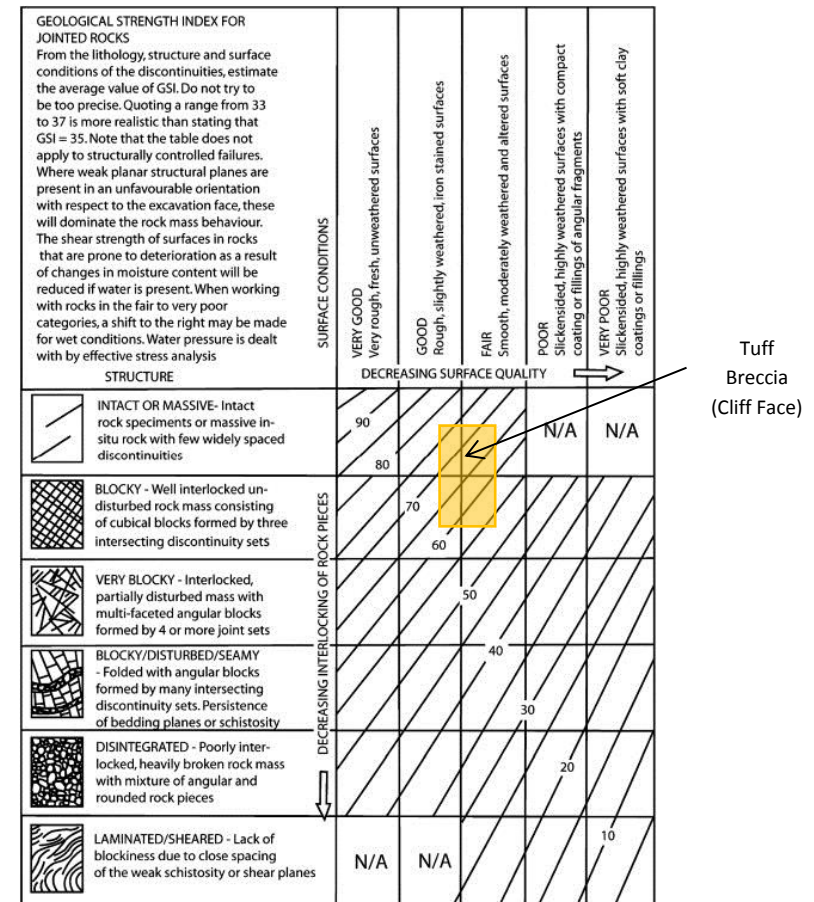
NE Face:                    ~ 55 – 82                    ~ 18 – 45

SE Face:                    ~ 45 – 77                    ~ 23 – 67

Tuff:                                    ~ 54 – 77

**Figure 22 – Estimated range of GSI values for the unwelded, welded ignimbrite, and tuff units taking into consideration of on the (weathered) pre- and post-collapse conditions of cliff face (modified after Hoek et al., 2002)**

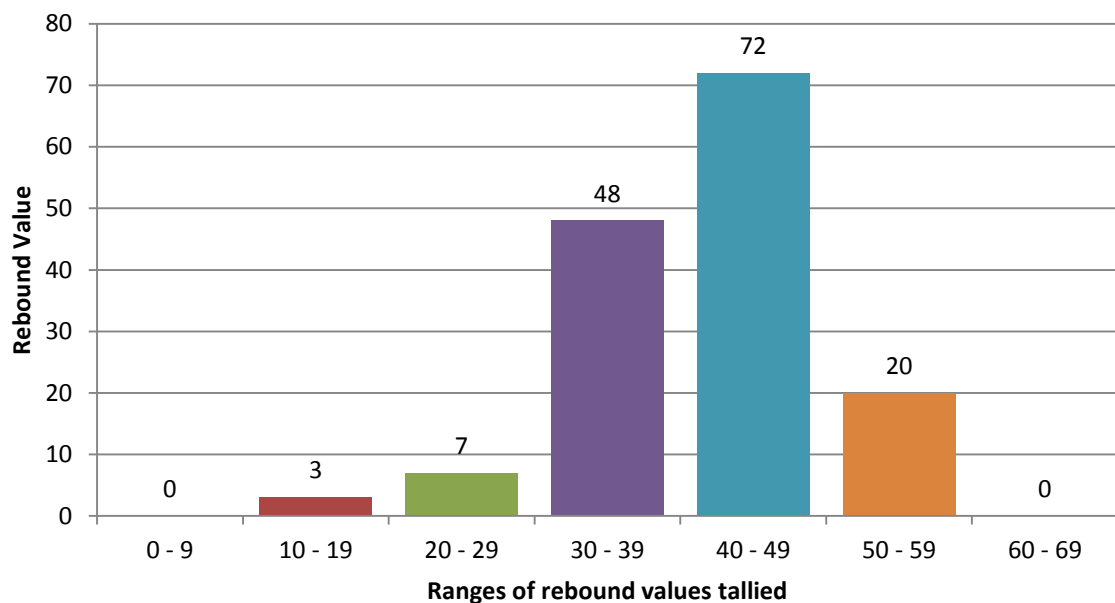
majority of the R values are  $\geq 30$ , with the highest concentration (72 out of 150) found within the index rebound range of 40 – 50 (Figure 26).

Figure 26 – Tally of R values illustrating the spread of 150 R-values measured at the proxy site on welded ignimbrite.

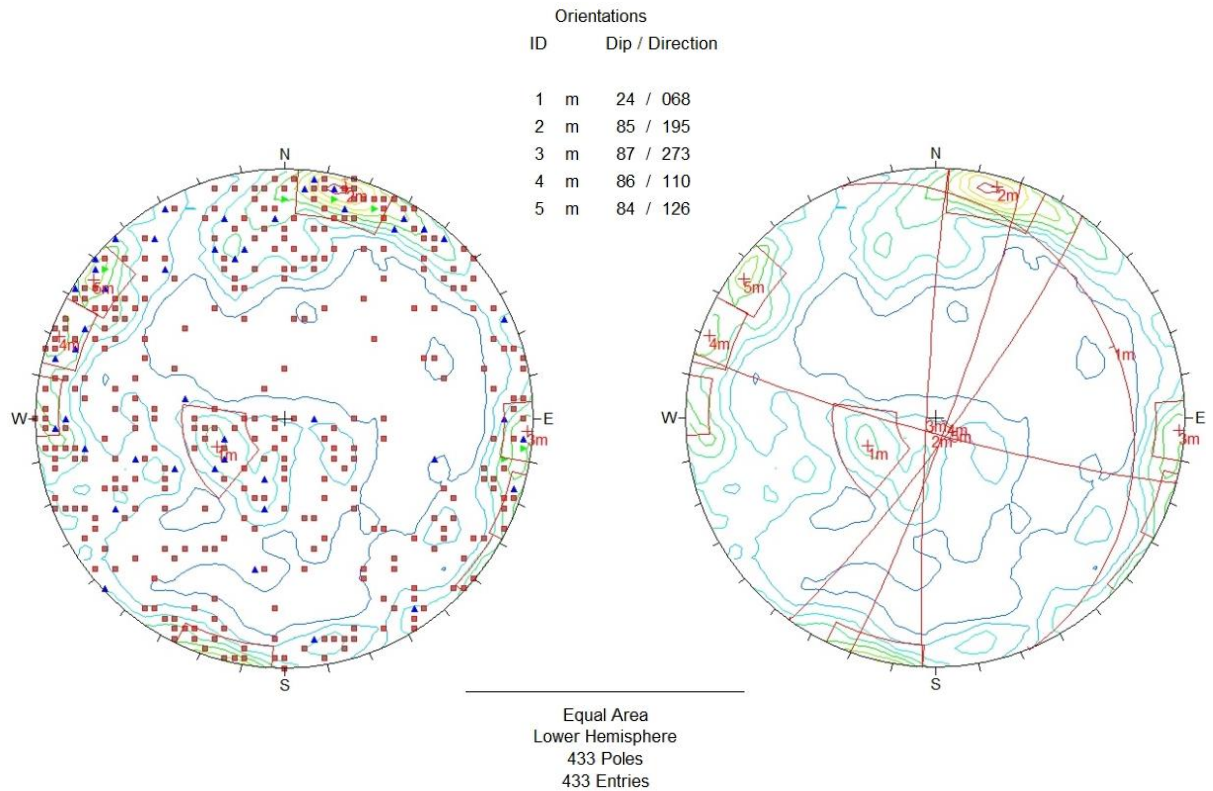
Figure 29 – Stereonets representing all 433 poles derived from plane and trace measurements taken from all the 3D photogrammetry models. The left stereonet shows the individual plots and the sets selected based on the concentrations of plots. The right stereonet shows the resulting planes drawn based on the sets selected.

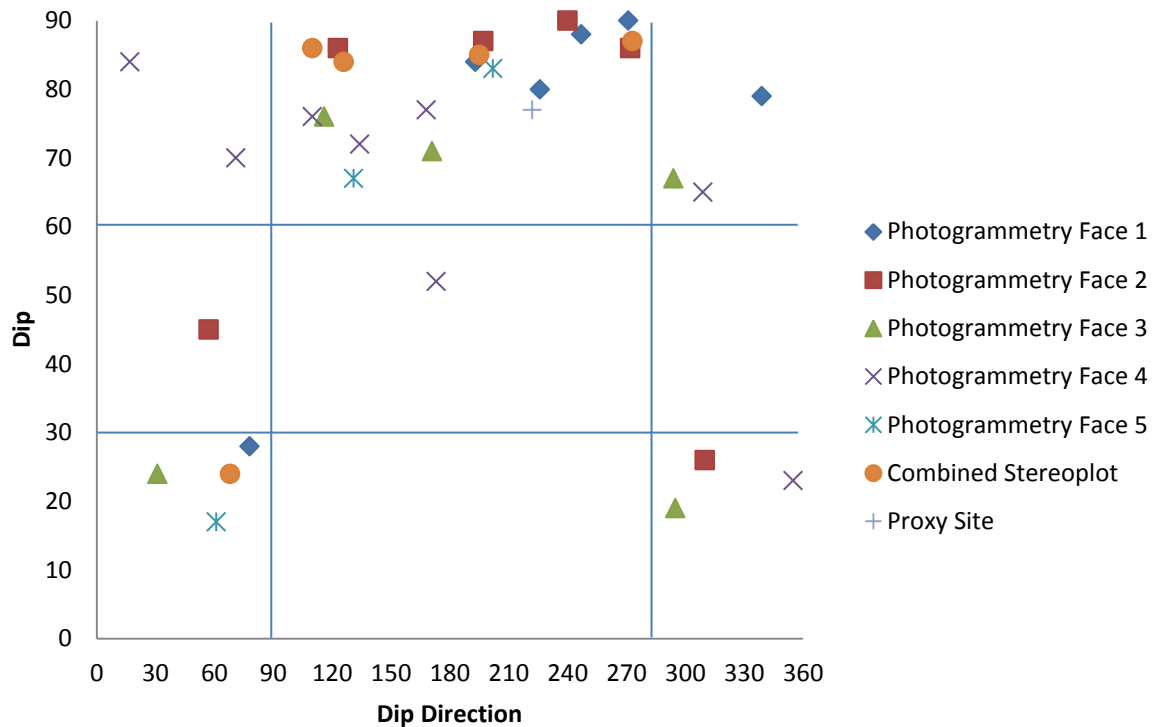
Figure 31 summarizes all the joint sets isolated while analysing the various stereonet, revealing distribution patterns. The most obvious pattern of which is that majority of the dip of the joints are  $> 60^\circ$  and a small minority are  $< 30^\circ$ . This array of steeply / near-horizontal dipping joints supports the observation that the welded ignimbrite has steeply dipping (columnar) joints, as well as cross-joints, i.e. irregular intersecting joints that are roughly perpendicular to the prism axis (Spry, 1962), which influences the persistence of the near-vertical joints, and thus the overall size of the intact block.

Figure 30 - Graph summarizing the distribution of discontinuity sets identified while analysing dip/dip direction data using Dips.

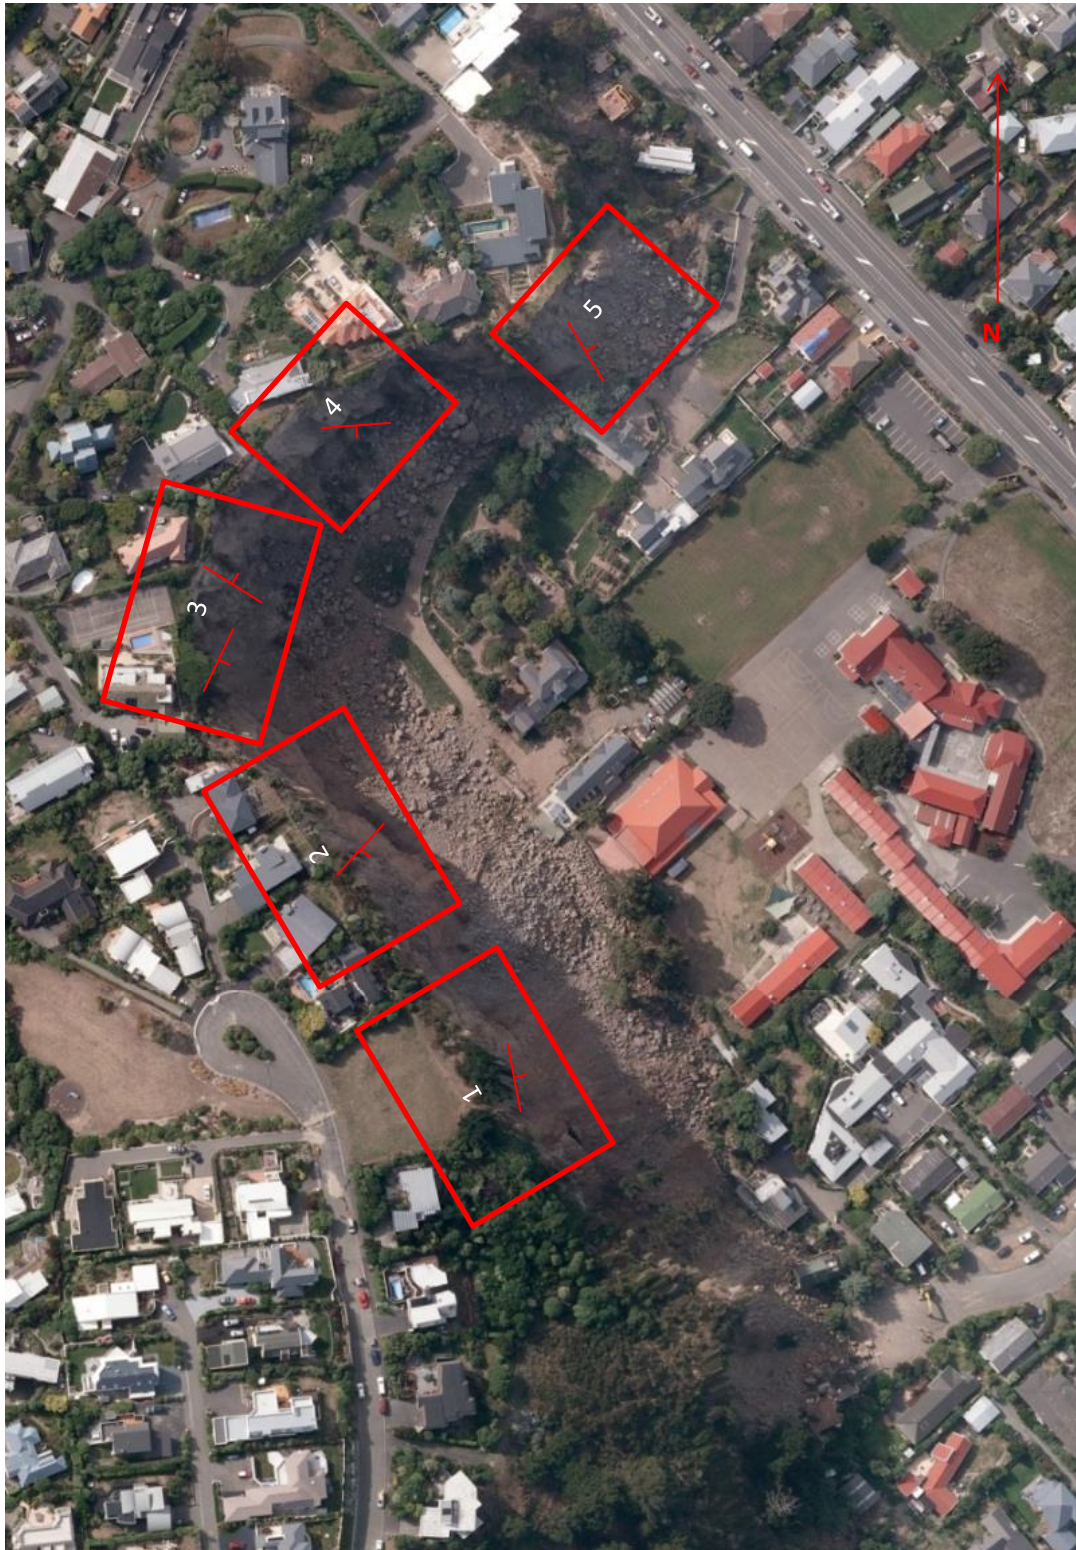
Moreover, as for the near-horizontal discontinuity sets, there is a contrast in orientation compared to the steeply dipping joints, whereby the cross-joints dip in the general north direction, with Photogrammetry Faces 1 and 5 favouring the NE, Faces 2 and 4 favouring the NW, and Face 3 favouring both directions. It was initially thought that these near-horizontal discontinuities were merely cross-joints, however after mapping the strike and dip orientation of these near-vertical discontinuities (Figure 31), it is within reason to assume, based on the overall direction of the dips, that the dip range  $16^{\circ} - 28^{\circ}$  and corresponding dip direction of  $30^{\circ} - 75^{\circ}$ ;  $300^{\circ} - 355^{\circ}$  represents the bedding orientation (Hampton, S., 2013, pers comm. 13 June).

Figure 31 - The strike and dip orientation of the main near-horizontal discontinuities mapped on the cliff face, showing general direction of the dip is in a SE direction

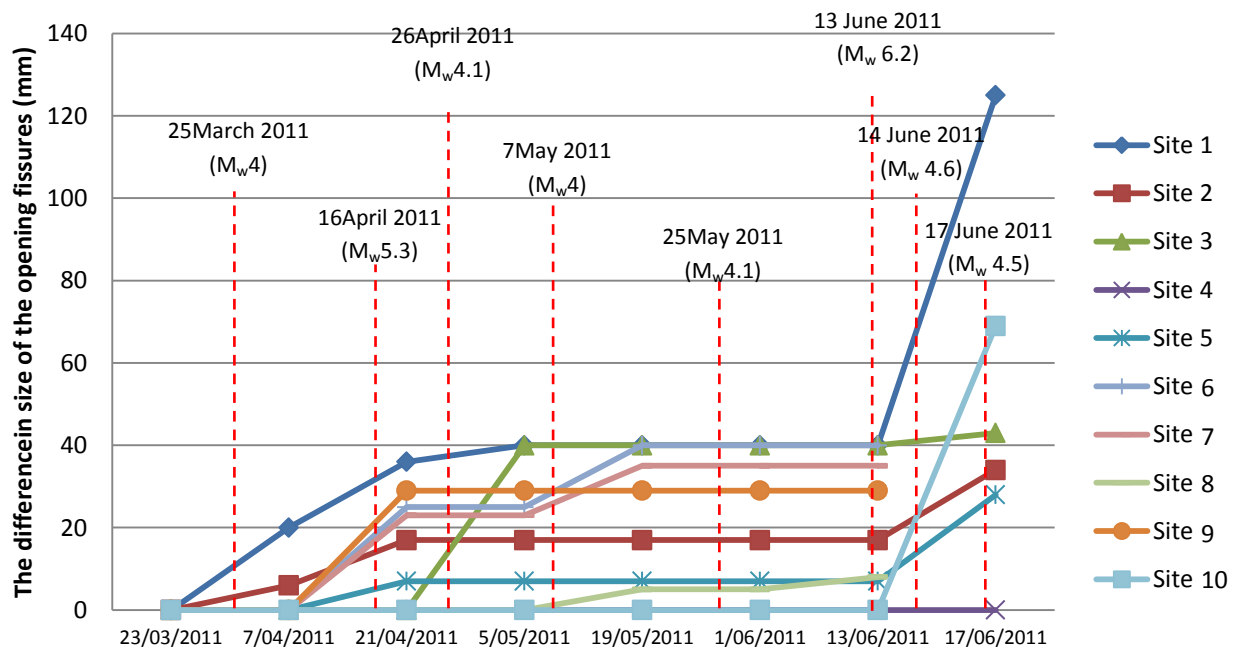
According to the survey results, there was a contrast in behaviour throughout all 10 of the fissures monitored over the three or so months (Figure 38). Most of the fissures did widen over the monitored period of time (sites 1 – 3, 5 – 9), except for site 4 and 10 – which only widened after the 13 June earthquake. Additionally, old fractures that developed in the 22 February 2011 earthquake were destroyed and new ones created as a result of the 13 June 2011 earthquake at sites 7 – 10.

Figure 38 – Results of incremental widening for fissures monitored fortnightly between March and June 2011, starting at 23 March 2011. Each point represents the difference (i.e. increase) in the size of the fissures with respect to the previous measurement, and the red dashed lines represent key seismic incidents within the timeline.

Overall, despite the limited amount of data collected, it was enough to suggest that seismicity is the leading cause behind widening of the fissures. However, even though there is no distinctive pattern in the correlated data to suggest rainfall as major influence, from a strength perspective, as demonstrated with the scala results in saturated soil, it is likely that saturation of the soil would have contributed to some extent towards helping widen the fissures in the event of a large enough quake.

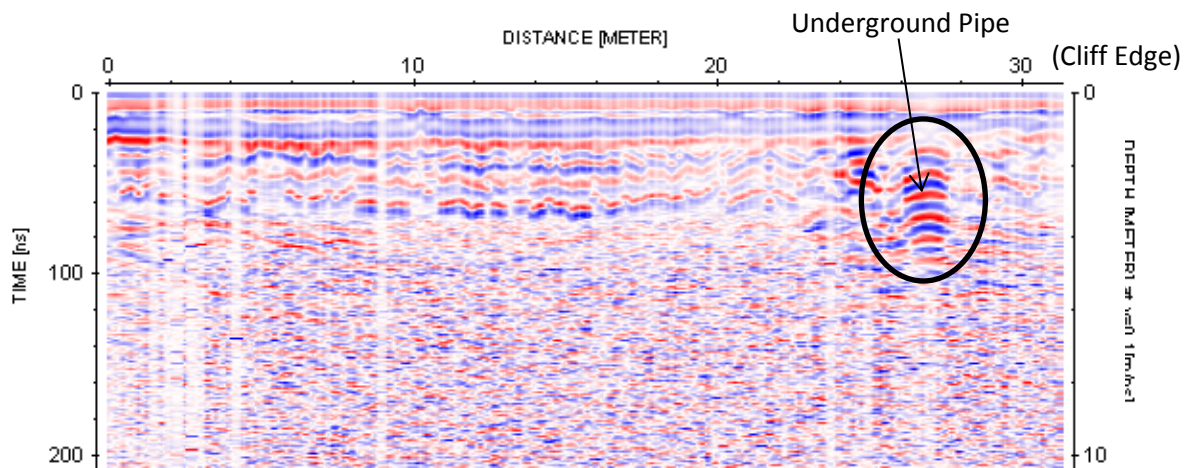
The conclusions drawn from the results obtained from the GPR and Resistivity Imaging established that neither method was successful in imaging the subsurface geology of the cliff. Both methods were successful in identifying the underground pipe close to the edge of the cliff (Figures 40 and 41). However, both surveys only managed to survey down to ~4 m into the cliff. This meant that even though it was possible to detect subsurface features (such as the pipe near the cliff edge), the lack in depth of penetration from both geophysical methods meant that it was not feasible to proceed with the methods on the selected surface fractures of interest since neither methods could penetrate into bedrock.

Figure 40 - Result from the GPR survey of the test site successfully imaging only down to ~4 m of the cliff top

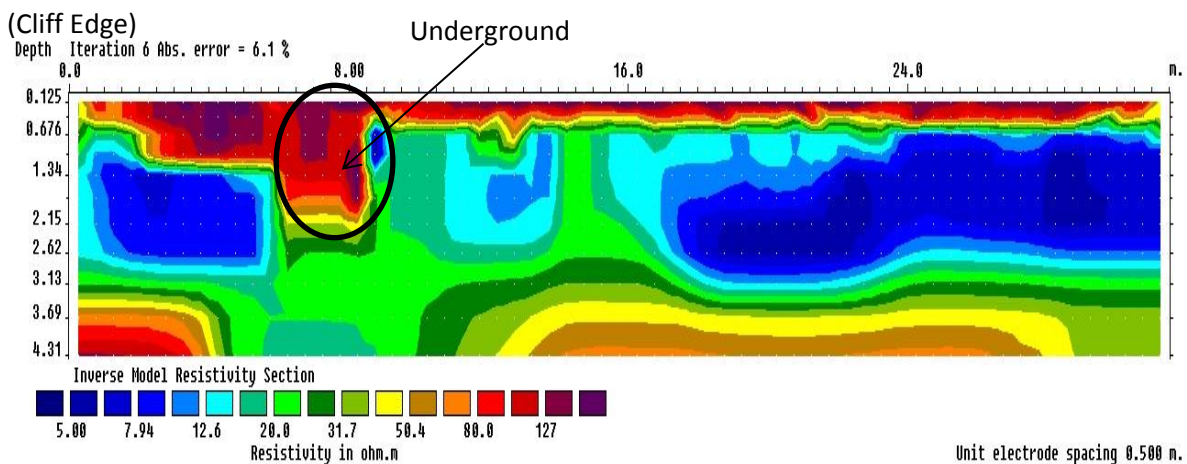
Figure 41 - A graphical representation of the resistivity tomography survey conducted imaging down to just over 4 m into the cliff

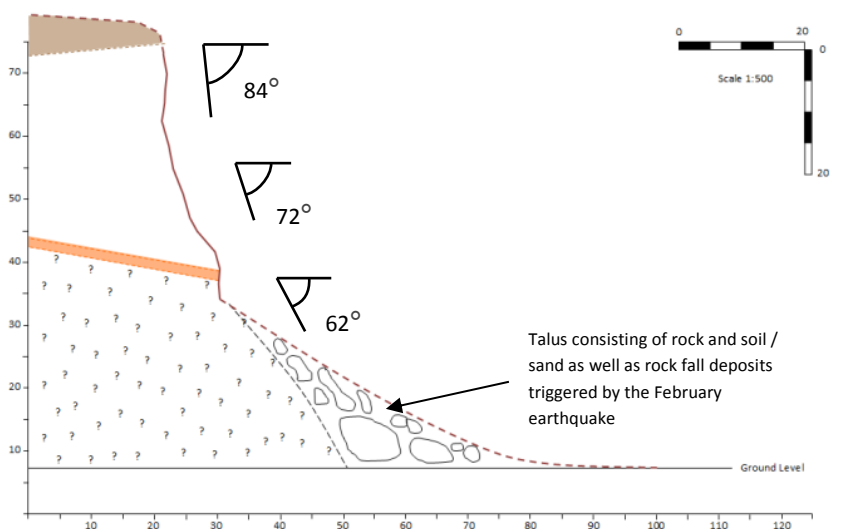
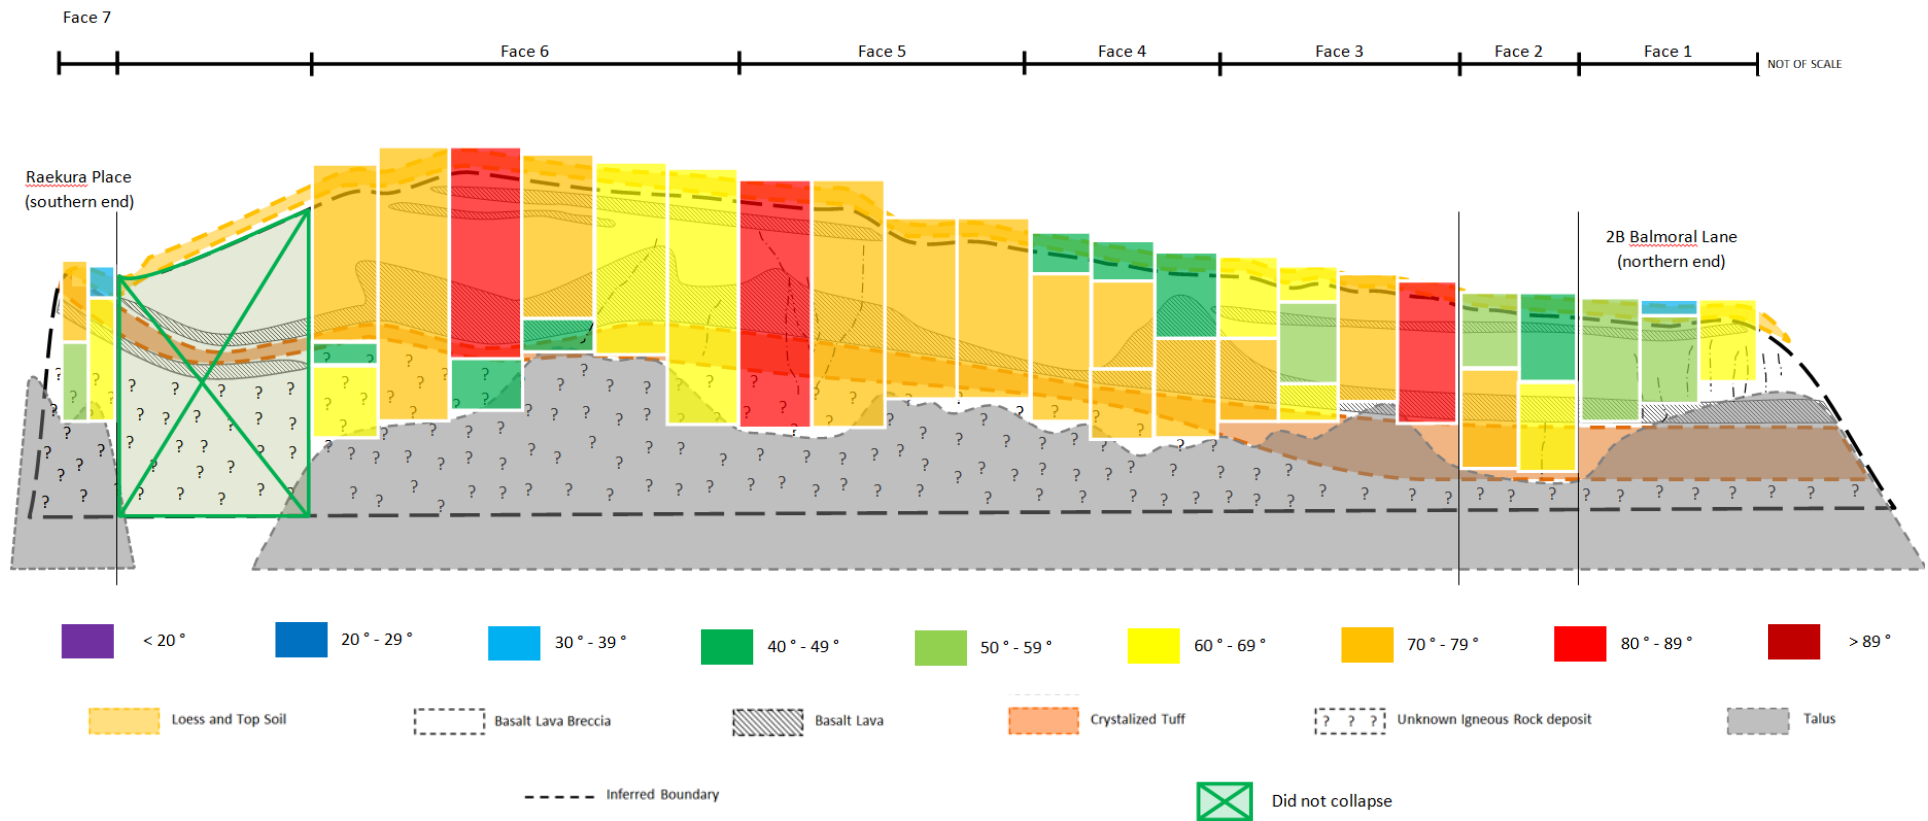
(A) Pre February 2011

Figure 43 – Models of Redcliffs' cliff illustrating the major cliff-face gradients surveyed before and after each major collapse. (A) pre-February 2011, (B) post-February 2011; (C) post-June 2011

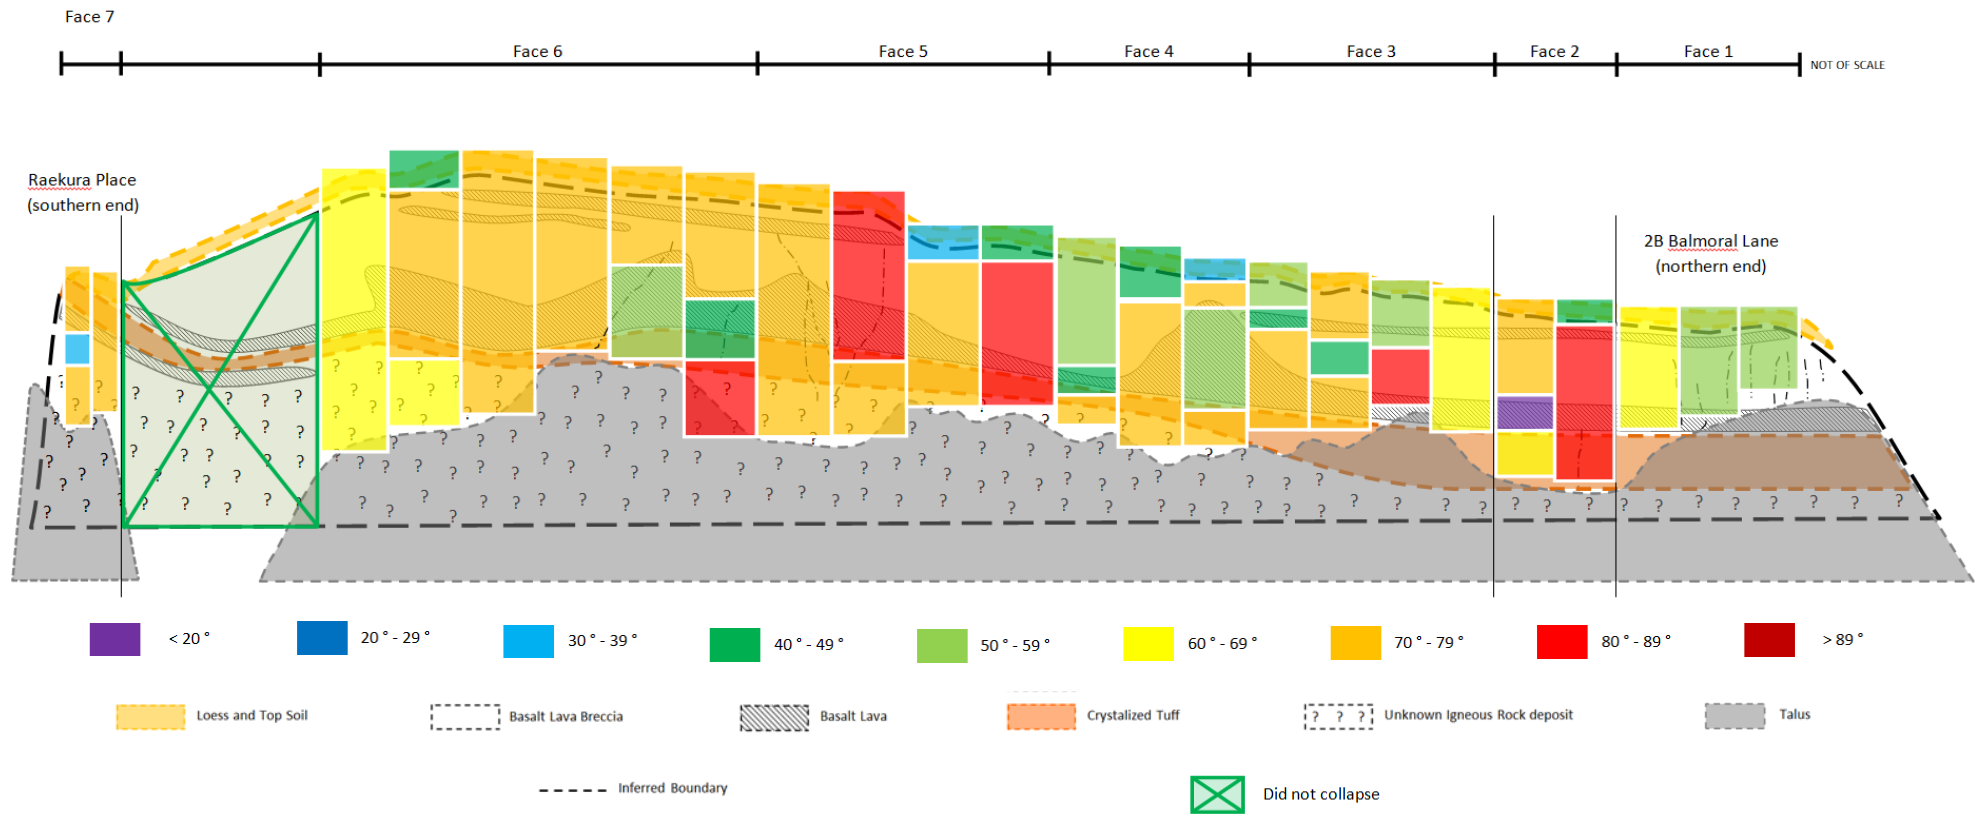
(B) Post February 2011

Figure 44 – Slope geometry after the 22 February 2011 earthquake. See Figure 43 for annotation.

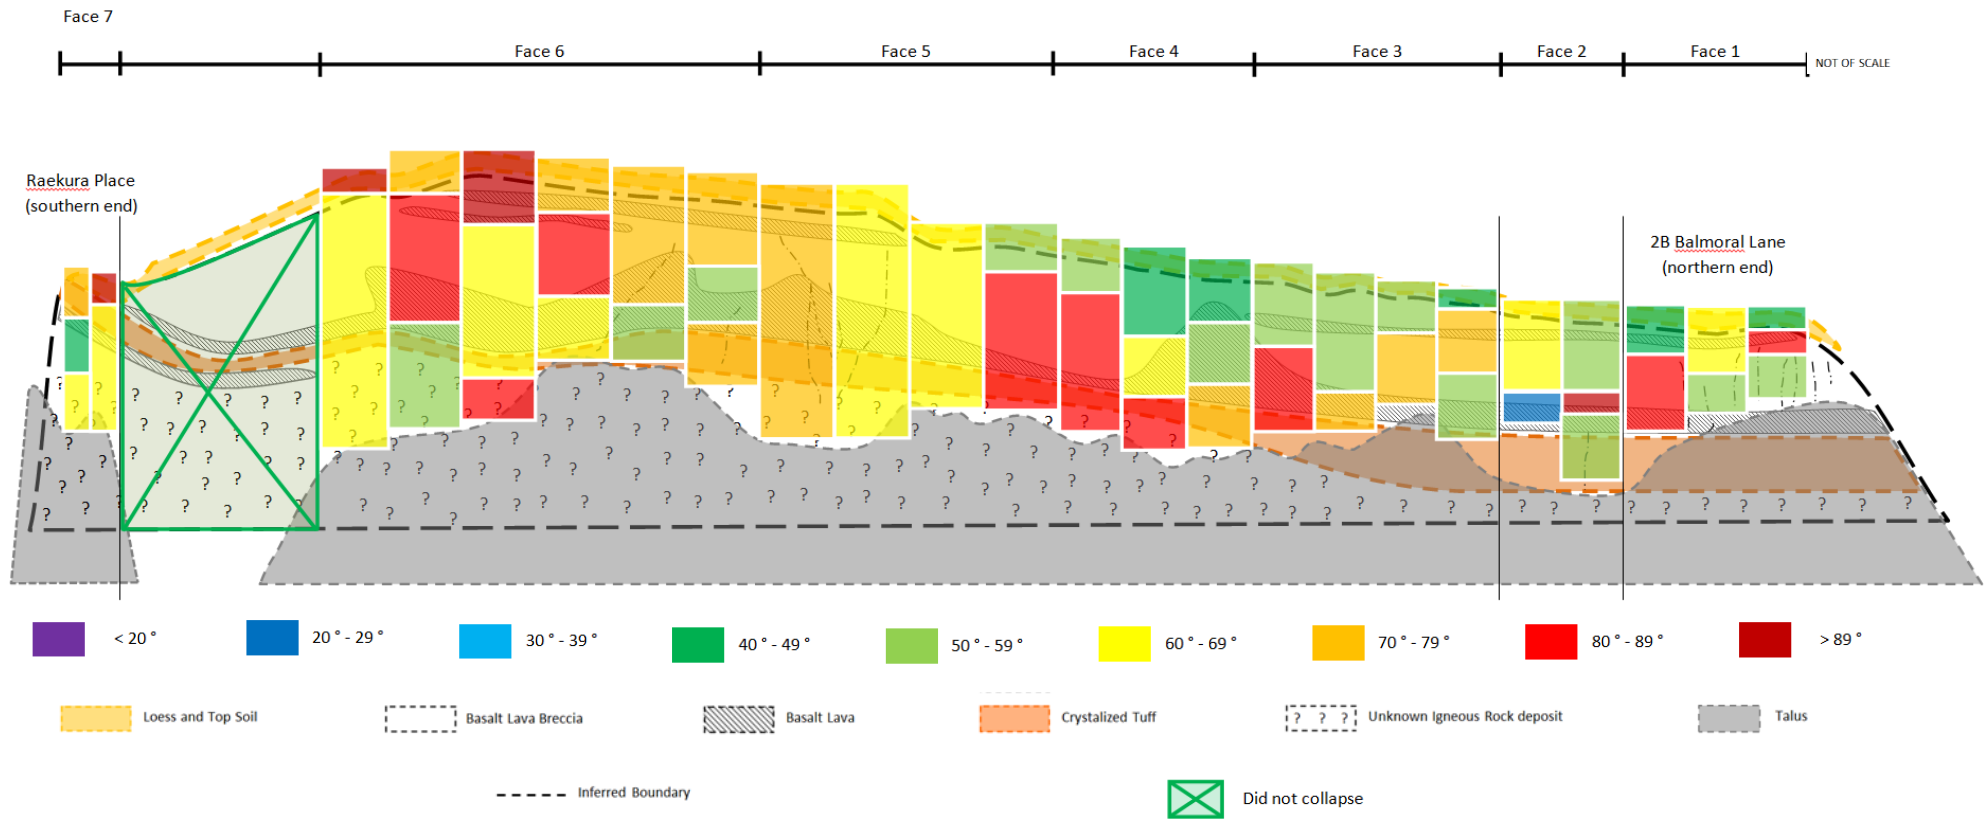
(C) Post June 2011

Figure 45 - Slope geometry after the 13 June 2011 earthquake See Figure 43 for annotation

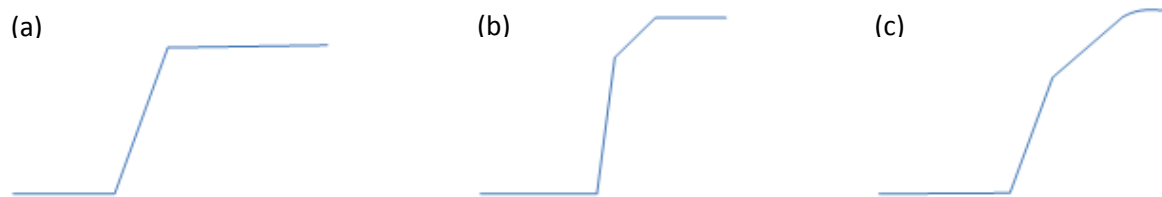
After examining all the cross-sections, three common slope-outlines were identified which represented the general slope profile across the cliff (Figure 46). Each of these three cross-sectional slope profile shows that the cliff face is made up of different slope angles and varying numbers of major slope gradients of different sizes. This is attributed to the heterogeneous nature of the rock masses that combine to make up the main rock body of the cliff.

**Figure 46 - Outlines of the three major cliff profiles present across the Redcliffs cliff face. (a) A cliff profile representing a slope either strong rock formations that of the same rock mass strength or a relatively strong top. (b) A slope with a weak top and a strong base / main body. (c) An overall weak slope with an even weaker top.**

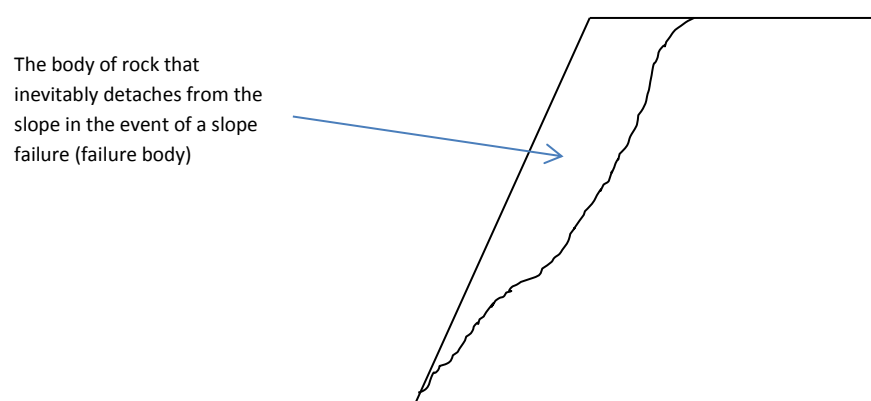
For the first collapse in February 2011, the slope movement was classified as a structurally-controlled Discontinuum, however, there is reason to suggest that (partial) Equivalent Continuum could have occurred as well. The idea was brought on by considering the overall structural condition of the inner and outer (near-surface) part of the slope (i.e. the distribution and frequency of discontinuities; the variable block sizes throughout the body of rock) that inevitably detaches from the cliff (failure body; Figure 52) in the 22 February 2011 earthquake.

**Table 52 – Illustration of a ‘failure body’, which represents the section of the cliff face that inevitably fails; describing all the blocks of rock that detach from the cliff face as a whole.**

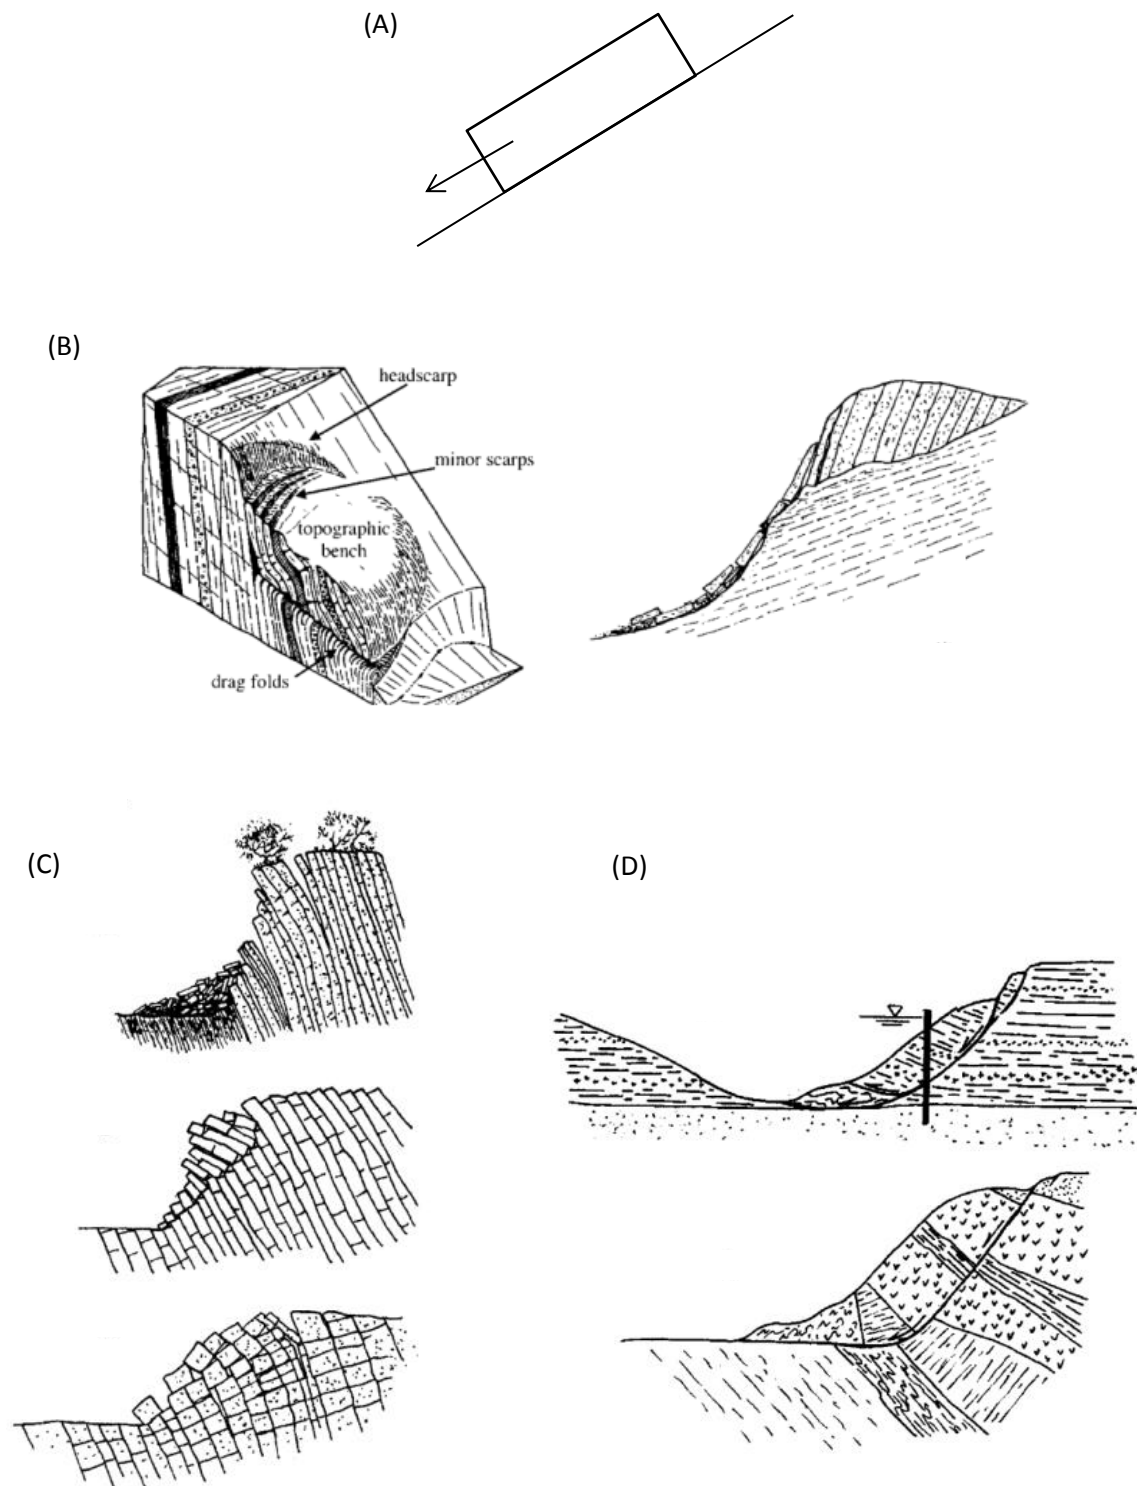
Figure 56 – Illustrations of the failure mode descriptions selected that match the descriptions of the soil and rock masses that make up Redcliffs' cliff. A) Block sliding on a single plane; B) Rock slumping; C) Toppling; D) Rock Bridge cracking; D) Soil type slumping (images for B – D are provided by Goodman and Kieffer, 2000).

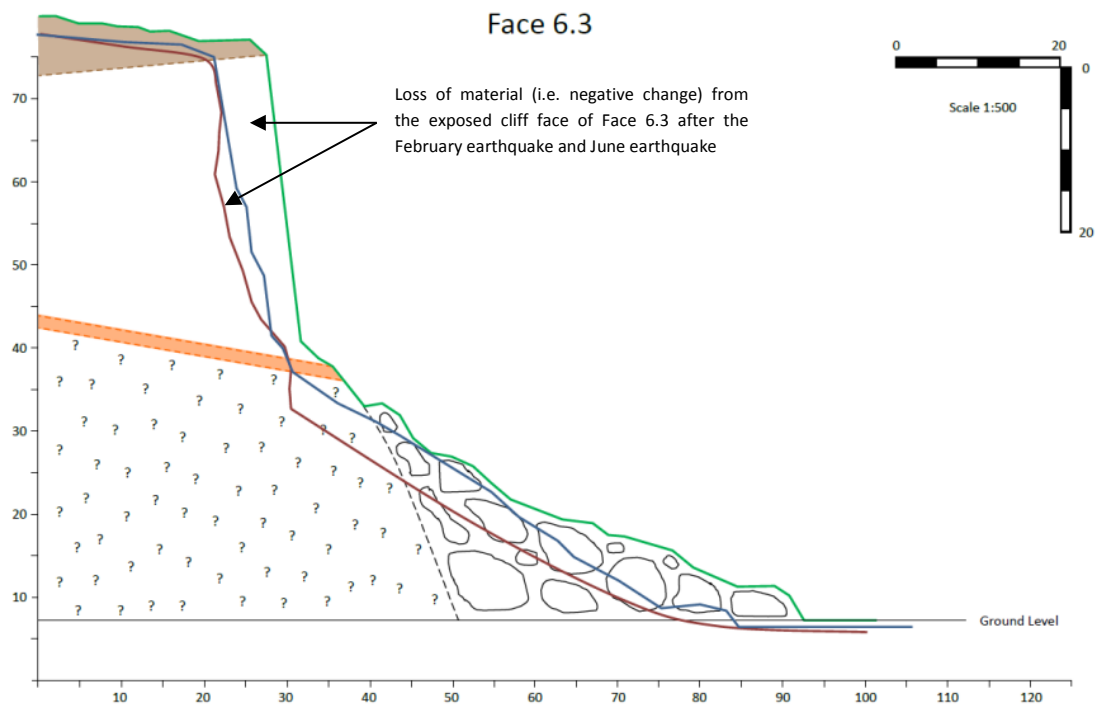
Figure 57 - An annotated example of overlapping cross section Face 6.3.

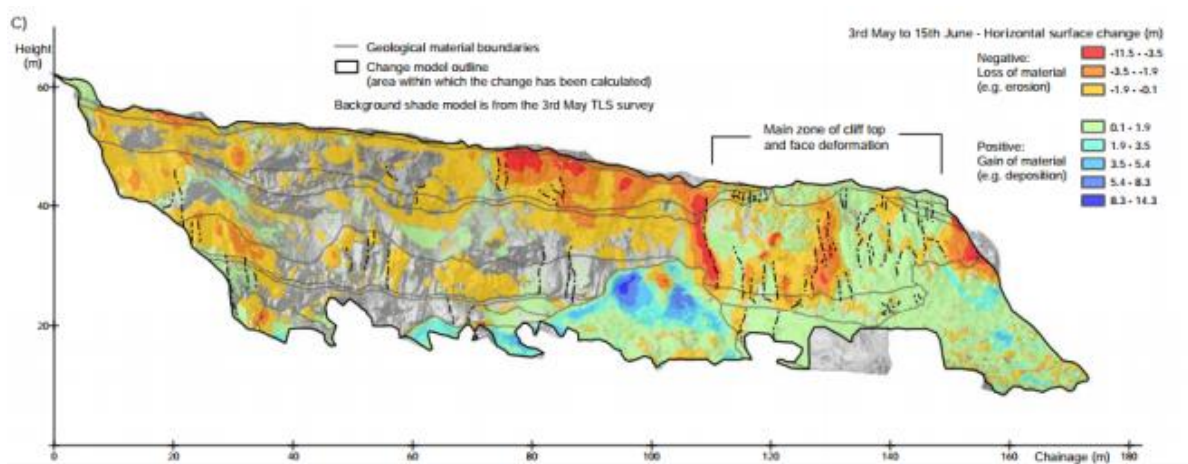
Results of this comparison (Figure 58) shows that the post-February and (most of) the post-June 2011 cross sections exhibited loss of material in the form of a receded cross sections outlines from the overlapping of cross section. However, a few sections of the NE Face did reveal an alleged “positive change”, i.e. gain in material on the slope after the June earthquake.

It is very likely these positive overlaps are false readings, as the range of error is rather high as survey (laser scan) models with contrasting resolutions were combined to produce an overlapping sequence. However, there is a possibility that the overlaps may hold some truth considering that Massey et al (2012) also noted a positive gain on the surface of the NE Face after the June earthquake as well (Figure 58).

Figure 59 - Surface change model of Redcliffs' cliff face created to represent the cliff face after the June 2011 earthquake (Massey et al., 2012).

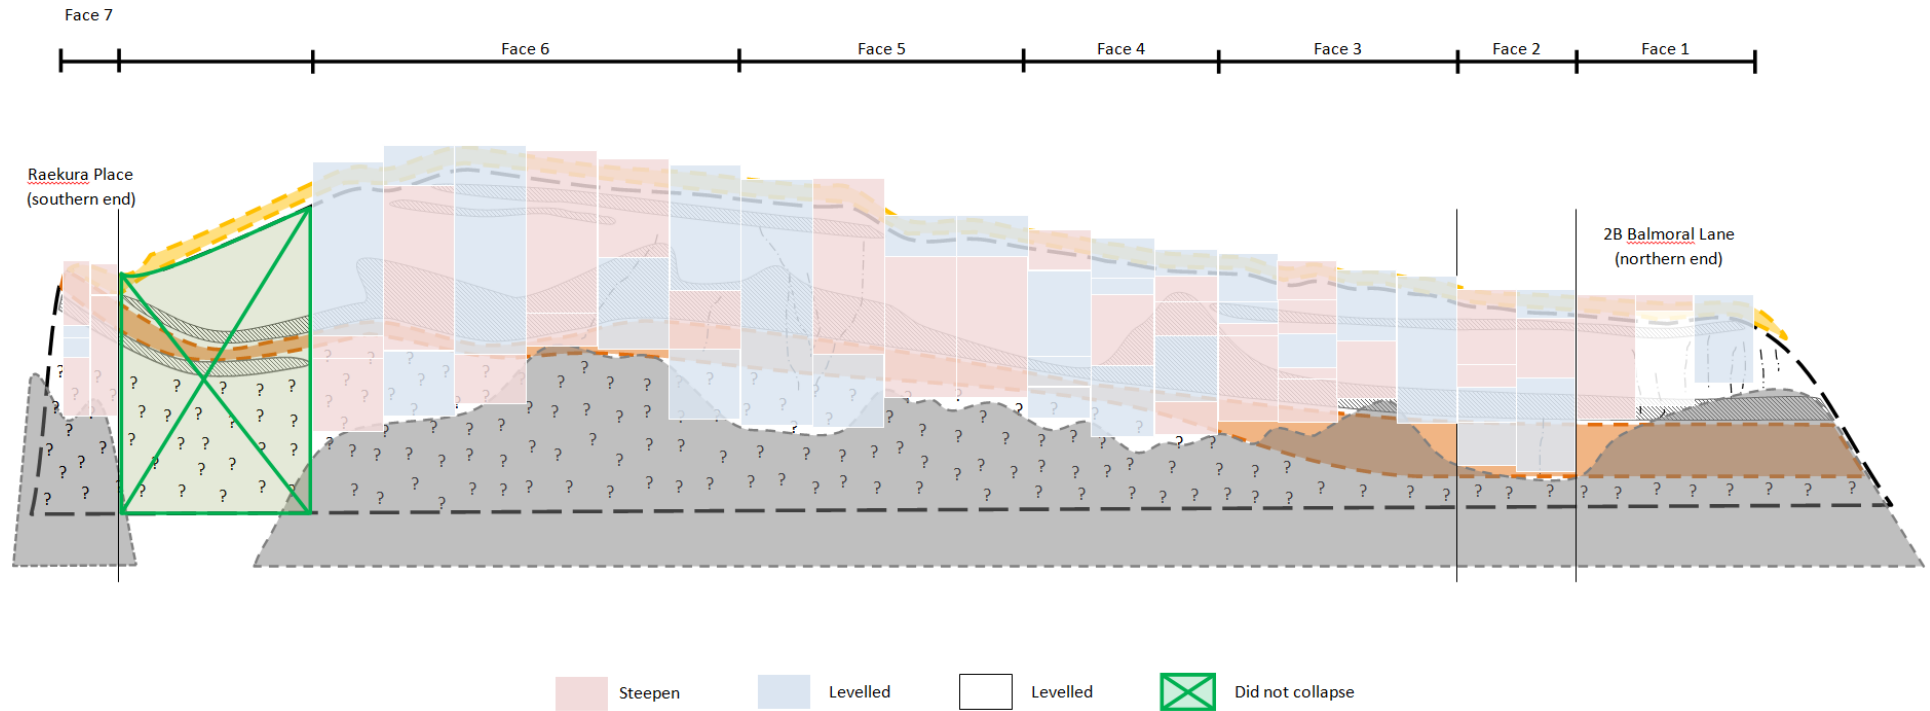
Figure 60 - The resulting different in slope gradients after the first collapse in February 2011, based on overlapping the slope gradient measurements Figure 43 and 44.
